LESSONS LEARNED FROM 10 YEARS OF LEAK DETECTION SURVEYS ON GEOMEMBRANES

B. FORGET, A.L. ROLLIN and T. JACQUELIN

SOLMERS INC., 1471 Lionel-Boulet Boulevard, Suite 22, Varennes J3X 1P7, Quebec, Canada

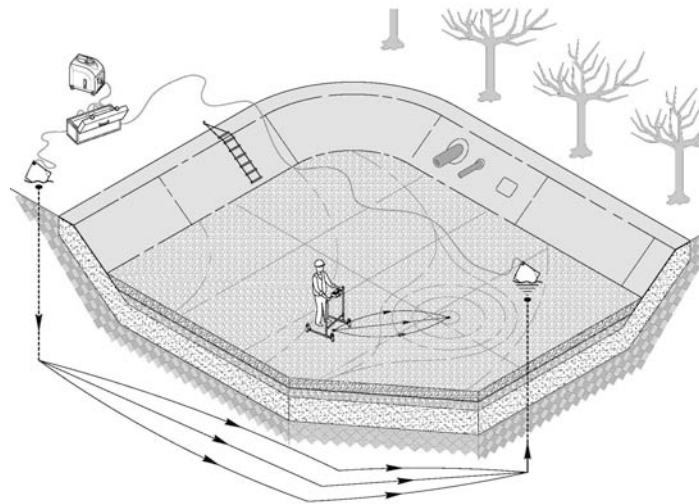
In the dipole leak detection technique, an electrical potential is applied between the covering material above the geomembrane and the soil below it. Since most synthetic geomembranes are effective electrical insulators, the presence of a leak creates a localized passage of current, which perturbs the potential field in a characteristic way. Leaks are located by recording potential readings with the dipole at predetermined grid densities.

Under moderate climatic conditions, on-site preparation is minimal. Spraying water on the covering soil surface might be necessary to insure good contact with the dipole under very dry conditions. The detection limit is variable but generally allows detection of holes with dimensions of 6 mm² or greater (ASTM D7007). Figure 2 provides a general schema of the dipole method.

Figure 2. Dipole technique on covered geomembranes.

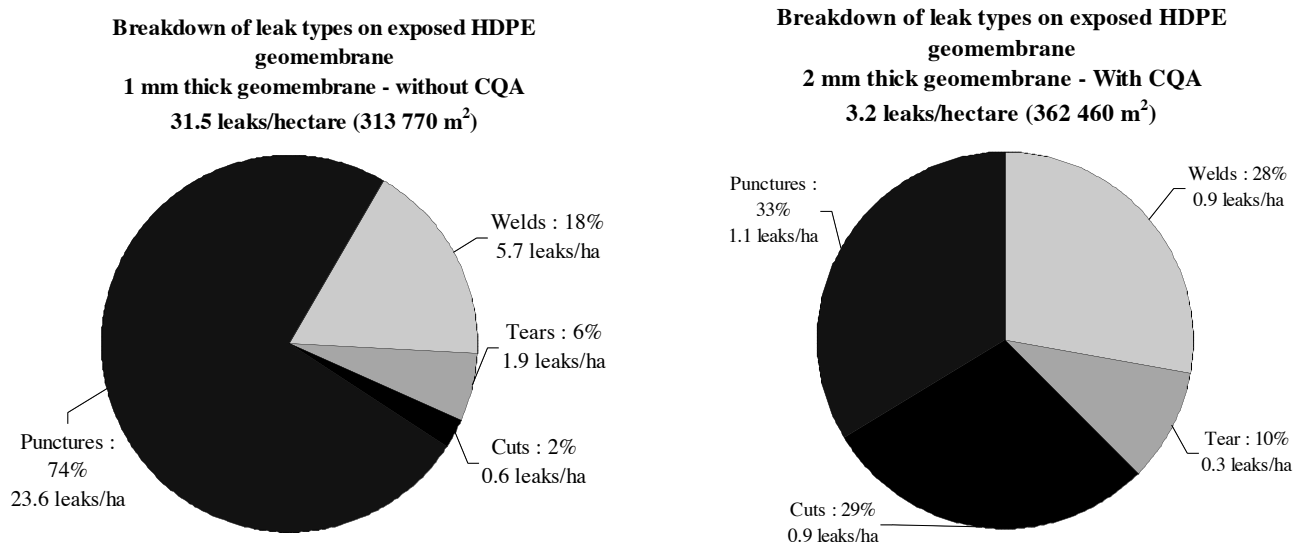
Figure 4 presents a breakdown of the different causes of perforations. The first graph considers the data obtained from exposed 2 mm HDPE geomembranes installed using a rigorous CQA program, and the second presents the results from exposed 1 mm HDPE geomembranes in the absence of a CQA program. It must be noted that this comparison deals with 2 variables due to the complete lack of data concerning 2 mm geomembranes installed without a rigorous CQA program.

Figure 4. Breakdown of Leak Types (Exposed HDPE Geomembranes).

- Confirming what has been previously published on this topic, approximately 30% of leaks are found at seam edges, and 70% are found on the panels;
- There is no correlation between the geomembrane thickness and the implementation of a CQA in regard to the number of knife cuts;
- The number of tears found is six (6) times greater for the 1 mm geomembrane without a CQA program than with implementation of a CQA program (1.9 vs. 0.3 leaks/ha);
- The number of faulty seams is six (6) times greater for the 1 mm geomembrane without a CQA program than with implementation of a CQA program (5.7 vs. 0.9 leaks/ha);

- The number of punctures is twenty one (21) times greater for the 1 mm geomembrane without a CQA program than with implementation of a CQA program (23.6 vs. 1.1 leaks/ha).

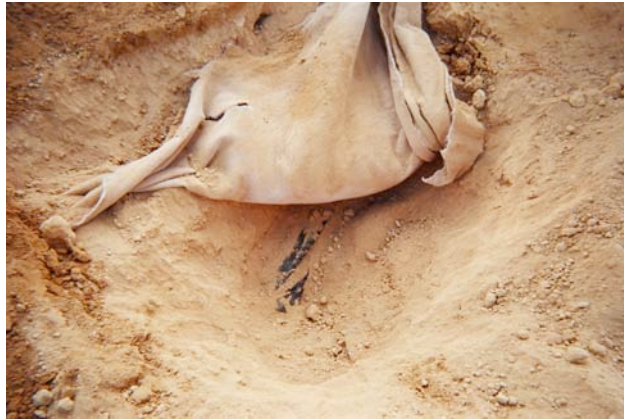
Figure 5 shows a typical geomembrane perforation originating from heavy equipment traffic on the covering material located at the cell bottom.

Figure 5. A one meter tear discovered using the dipole method, caused by heavy equipment during covering material placement.

Even though the leak densities on 2mm thick HDPE covered geomembranes are very low after the application of a rigorous CQA program (0.2 leaks/ha), it is important to mention that the vast majority of these perforations are caused by the heavy equipment traffic used during the installation of the covering materials. Consequently, the sizes of these perforations were found to be relatively large. This is corroborated by Nosko and Touze Foltz (2000) that characterised the dimensions of the perforations as a function of their type. Table 2 presents their results for covered and exposed geomembranes, while not taking into account the thickness or the presence or absence of a rigorous CQA program. It is interesting to note that the perforations caused by heavy machinery represent 75% of the tears greater than 10 cm².
