## Is electrical leak location helping us getting better with geomembranes?

C. Charpentier. Groupe Alphard, Canada. [ccharpentier@alphard.com](mailto:ccharpentier@alphard.com)

### ABSTRACT

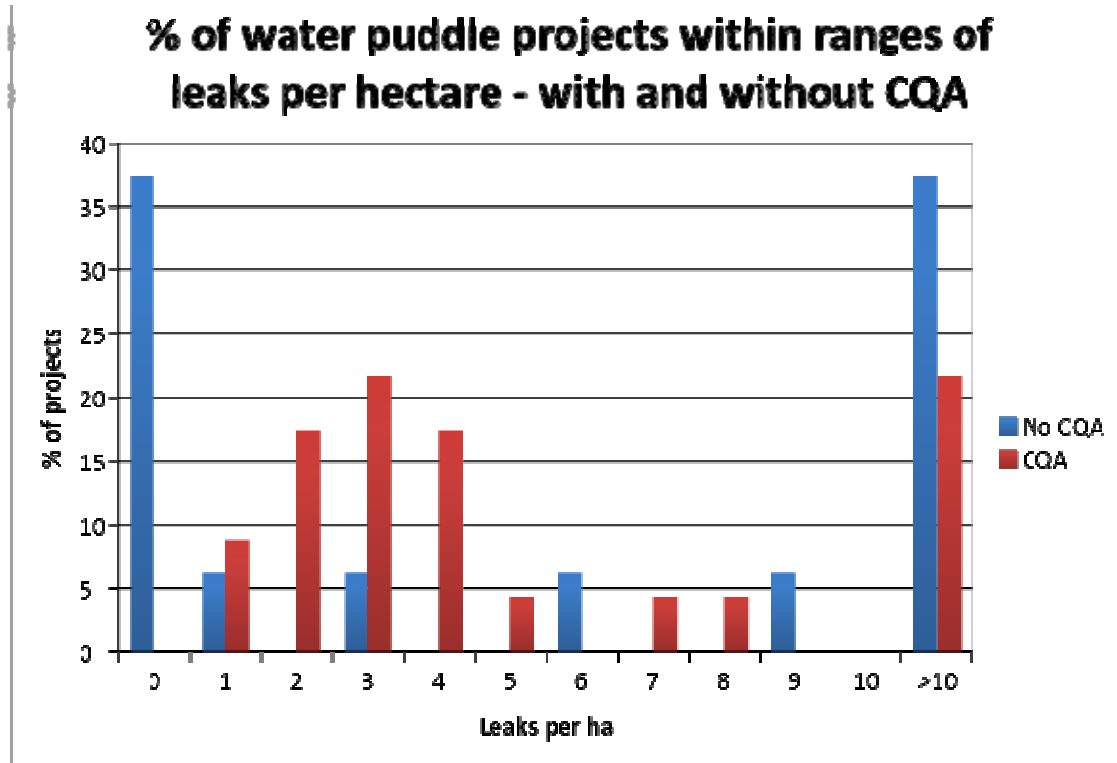
Figure 1. Graph showing percentage of water puddle projects within given defect rate ranges

When looking at the projects with and without CQA in terms of ranges of defect, the difference between CQA and non-CQA projects can be seen. Only 30% of water puddle projects with CQA have more than five leaks per hectare, compared to 50% for non-CQA projects. Similarly, a greater percentage of projects without CQA have more than 10 leaks per hectare (38% vs 22%). This would suggest that with a well-applied CQA program, there is a greater chance that the quality of the work will be consistent – without it, there risks having “outlier” projects with a much greater than average defect rates.

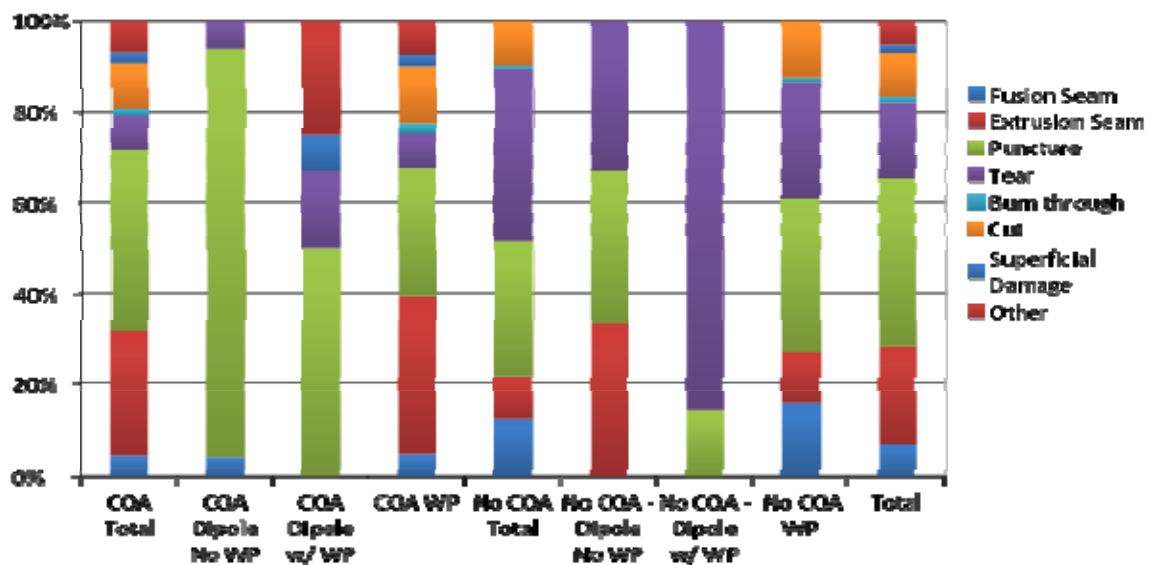
### Types of Leaks Found With and Without CQA

Figure 2. Types of leaks found with and without CQA

In general, tears and punctures are the dominant type of defect found in projects without CQA (68%), whereas for projects with CQA, it is punctures and extrusion defects (63%), with a greater diversity in other types of defects found.
